APOLLO RCS POSITIVE EXPULSION TANKAGE
PRODUCT IMPROVEMENT PROGRAM
FINAL REPORT - TASK E

SOLUTION OF COMMAND MODULE
AND SERVICE MODULE
BLADDER REPOSITIONING PROBLEMS

Bell Report No. 8514-928006
19 March 1970

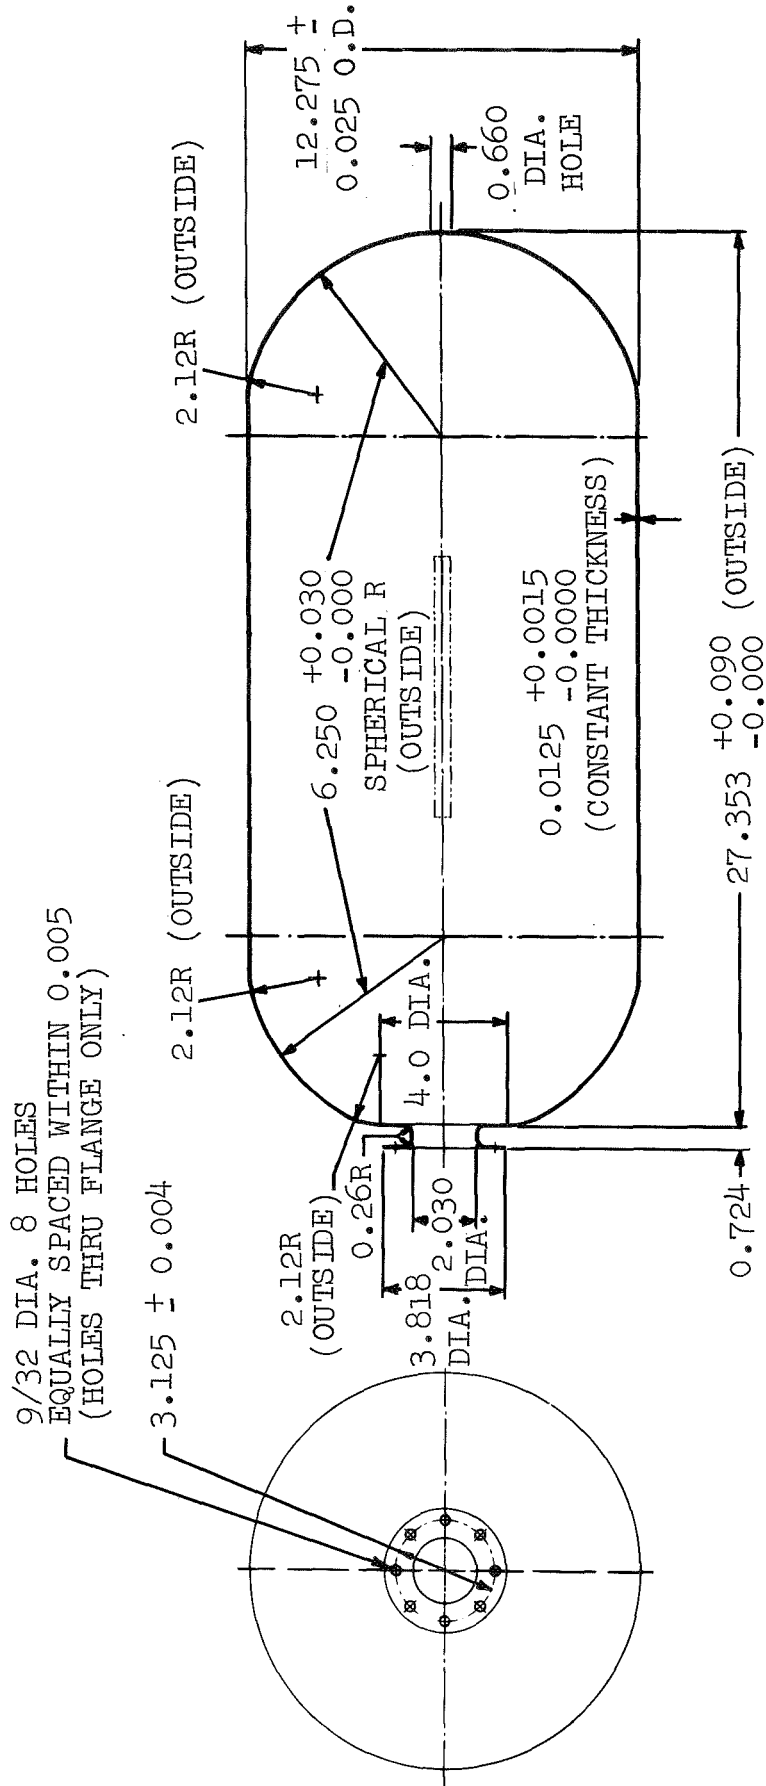
FIGURE 1. SEQUENCE OF TENSION DEVELOPMENT IN BLADDER

The Service Module repositioning problem is confined to the oxidizer tank and is caused by a marginal L/D ratio which results in high bladder-to-shell friction forces. The problem exists only when re-expanding the bladder after a liquid expulsion in the vertical attitude. During a liquid expulsion, the bladder is displaced downward in the tank due to gravity. At the end of the expulsion, the excess bladder material is collected at the bottom of the tank in the form of numerous tight folds and creases as shown in Figure 1. During subsequent re-expansion of the bladder, the cylindrical portion expands radially and contacts the tank shell before either of the hemispherical ends expands to any appreciable degree. Thus, due to the marginal L/D ratio, friction forces between the bladder and shell may exceed the available lifting force supplied by the pressure within the bladder and the bladder cannot reposition itself fully. As a result, the top hemisphere of the bladder is not supported by the shell and yields due to biaxial stress during subsequent servicing and loading operations.

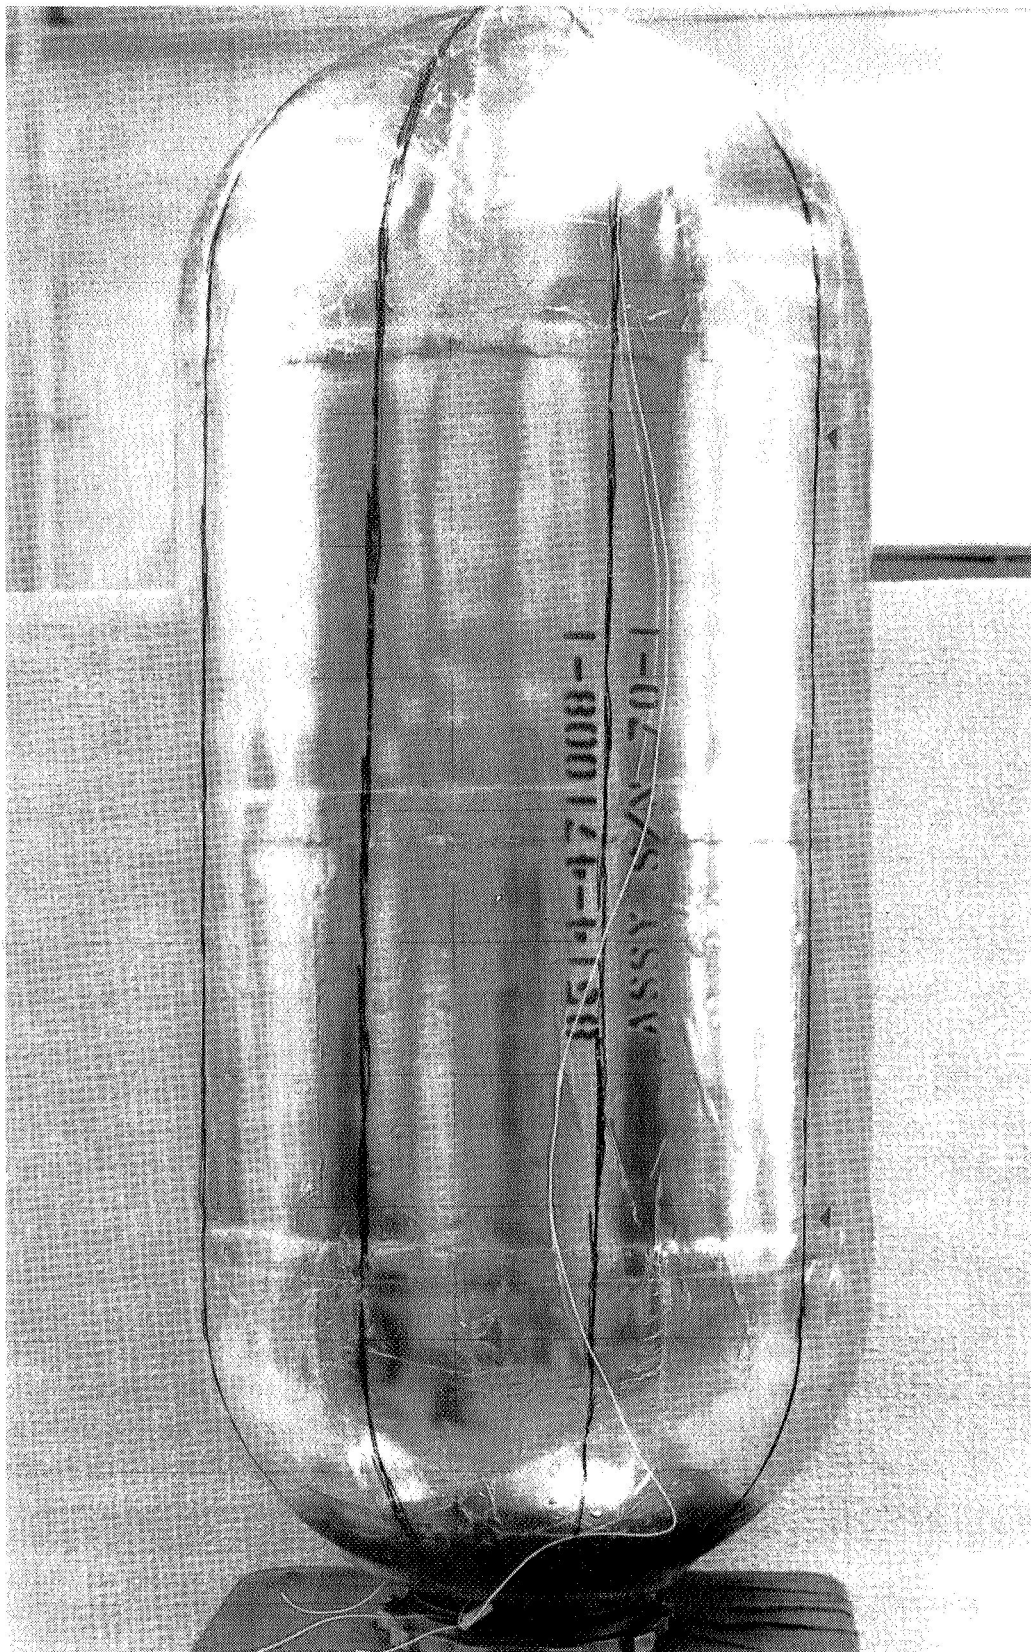
FIGURE 4. PLEXIGLASS TANK ASSEMBLY (SMO)

The test hardware consisted of one (1) 8514-471008-1 bladder S/N 70-1, one (1) 8271-471233 diffuser assembly S/N 29, and associated hardware to make a plexiglass tank assembly as shown in Figure 4.

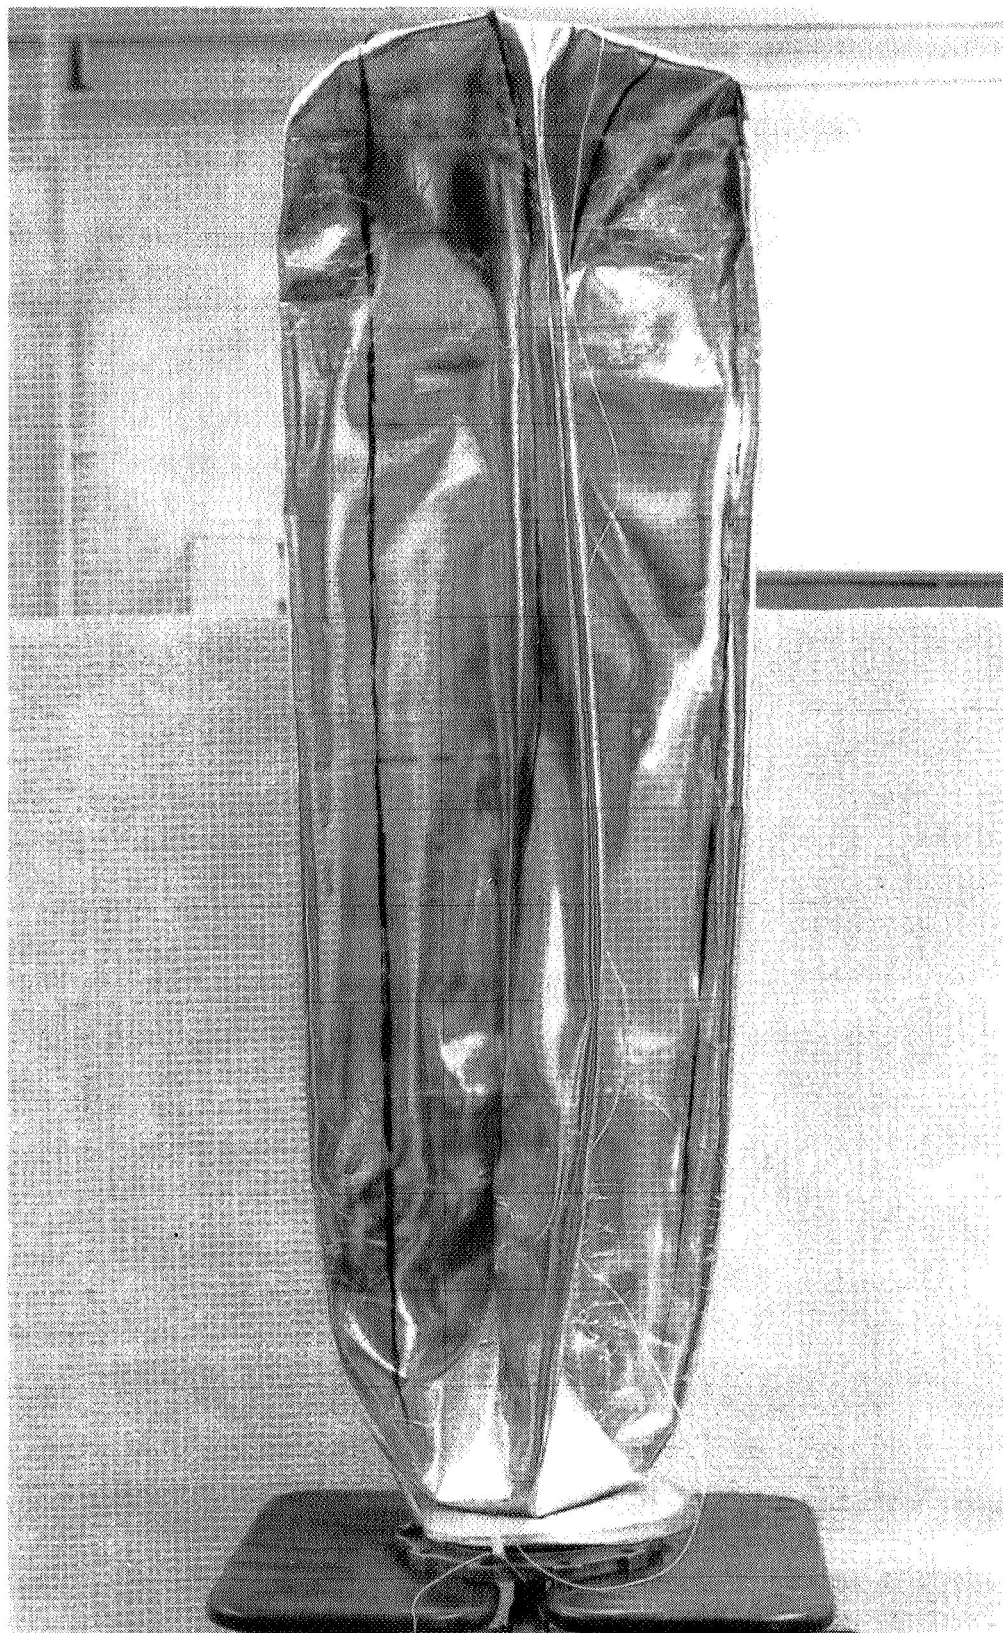
FIGURE 5. BLADDER ASSEMBLY, UNDERSIZED WITH FOIL LAMINATE (SMO)

The bladder was assembled on the diffuser tube as shown in Figure 5. Eight longitudinal orientation lines were made on the bladder to facilitate evaluation of bladder re-positioning characteristics. The bladder assembly was then evacuated and folded as shown in Figures 6 and 7 and installed into the plexiglass shell. Following the assembly into the plexiglass shell a 10 psi helium leakage test was performed on the bladder. After 1 hour, zero leakage was noted.

Accordingly, a bladder of the Service Module oxidizer (SMO) size was designed with the cylindrical section undersized 2% diametrically, similar to the Lunar Module and Saturn IV B bladder design. In addition, an aluminum foil laminate was added as a permeation barrier, based on the results of Task D of this program during which it was demonstrated that a film construction of this kind could be used in an undersized bladder. The results of Task D are reported in Bell Report 8514-928003. The bladder design is shown in Figure 2; the nominal design film thickness was 12.5 mil, consisting of 8 mil 20% TFE/FE codispersion, 1/2 mil aluminum foil, 4 mil FEP. The combining of these two innovations allowed a study to be made of the effectiveness of the foil permeation barrier as well as a demonstration of the effectiveness of the undersized bladder as a solution to the repositioning problem on the SMO tank.

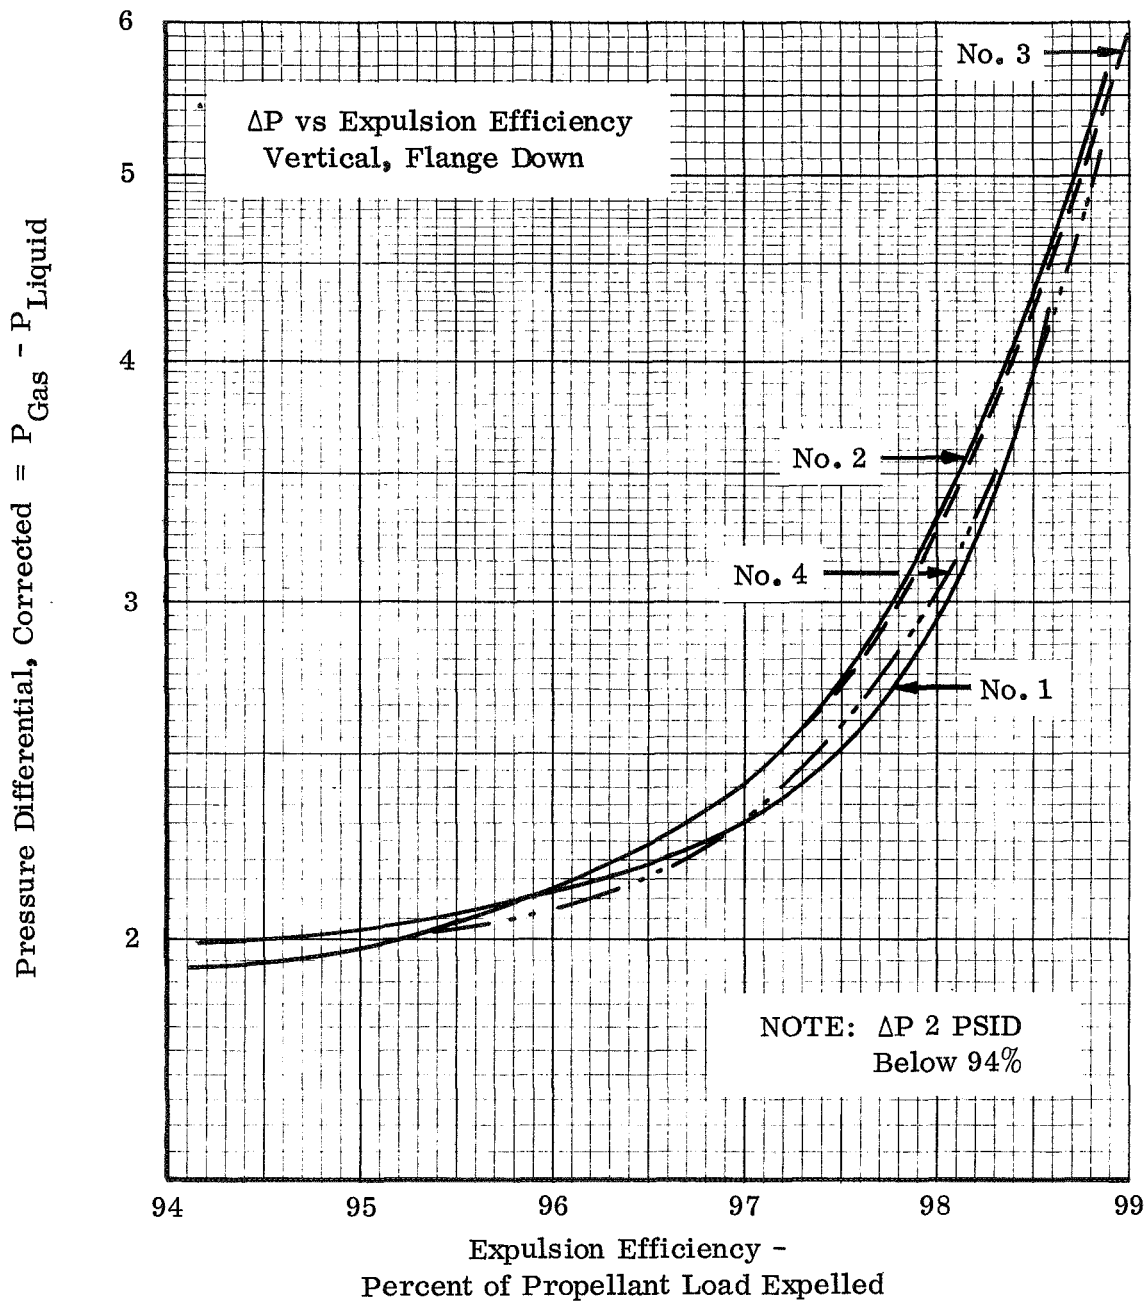
FIGURE 10. TEFLON/FOIL LAMINATE BLADDER - VERTICAL
EXPULSION - 100% EXPELLED - BOTTOM VIEW

As expected, the bladder repositioned itself completely within the tank when re-expanded after each vertical expulsion with no visible evidence of strain. The cylindrical section of the bladder did not touch the tank wall until complete vertical positioning had occurred. Figure 8 shows the bladder half-way through the first expulsion and Figures 9 and 10 show the bladder appearance after completion of expulsion. As shown in Table 1 and Figure 11, expulsion efficiencies exceeded 99% at a tank assembly ΔP of 6 psi.
